ISSUE REVIEW MEETING

*2019 ~ IRM 27
Summary Bulletin*

This year's 27th biannual IATA Issue Review Meeting (IRM), the IATA Safety Group (SG) and the IATA Hazard Identification Task Group (HITG) meetings, hosted by Cargolux, were held in Luxembourg, from September 10th to 11th, 2019.

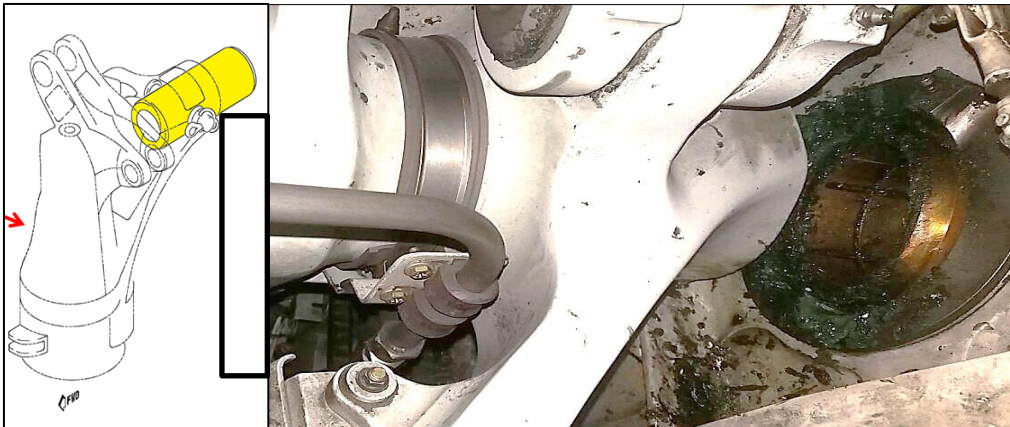
The touchdown in good weather conditions was firm, but not hard, with a maximum recorded g-load of 1.48g. After landing, when vacating the runway, the flight crew were informed by the cabin crew about an unusual loud noise coming from the landing gear area.

Engineering subsequently discovered that the aft part of the trunnion pin was missing and that the failure of the trunnion pin had caused substantial damage on other aircraft parts.

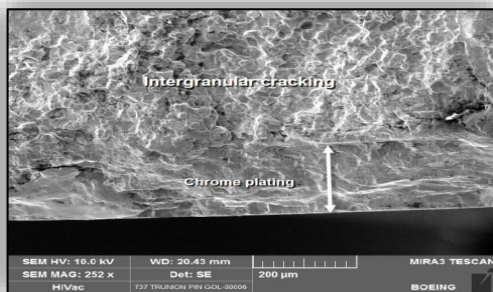
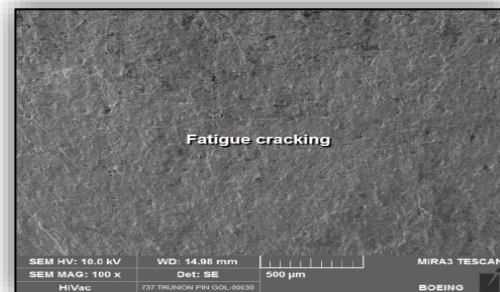
- Barkhausen Magnetic Noise Inspection (RMB)
- Fluorescent Penetrant Inspection (FPI) that revealed indications of cracking in the chrome layer in a corresponding region of the fracture origin point

- Magnetic Particle Inspection (MPI) that revealed signs of cracking in the same region pointed by the FPI, adjacent to the fracture origin point
- Scanning Electron Microscope (SEM) inspection, which identified an intergranular cracking caused by material fatigue

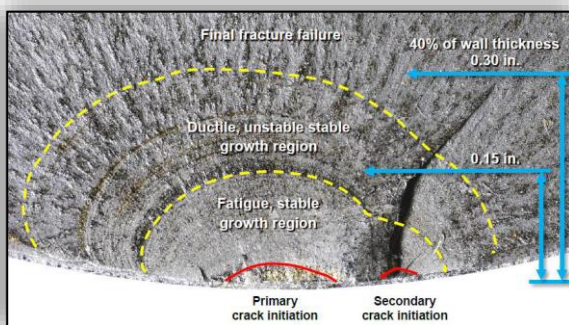
- A Metallographic Exam (ME), which confirmed the existence of a region of the metal microstructure that had been altered by the exposure to high temperatures and thereby negatively affecting its mechanical properties
- The Nital Etch Inspection (NEI), which revealed a dark area on the outer face of the base metal, encompassing the starting point of the rupture

It was concluded that normal operational cycles led to the initiation of a crack in the damaged base metal surface. It also revealed that the trunnion pin installed in the aircraft had been damaged during overhaul when the chromium layer machining process performed by the Maintenance Repair and Operations (MRO) was in disagreement with the procedures established by the manufacturer. Due to fatigue, the crack slowly and steadily propagated up to 20% of the pin wall thickness and unsteadily up to 40% within 3,969 cycles. It was later discovered that another operator with the same aircraft type had suffered similar trunnion pin failures.

- MROs have different automation levels in the machining process parameters, such as: cutting speed, feed rate and depth of cut. Less automation can increase the chance of human errors
- Visual and MPI inspections after the electrodeposition process may detect chromium cracking but not damages to the base metal
- It may not be possible to monitor a pin failure trend since there are no parameter changes during line operations

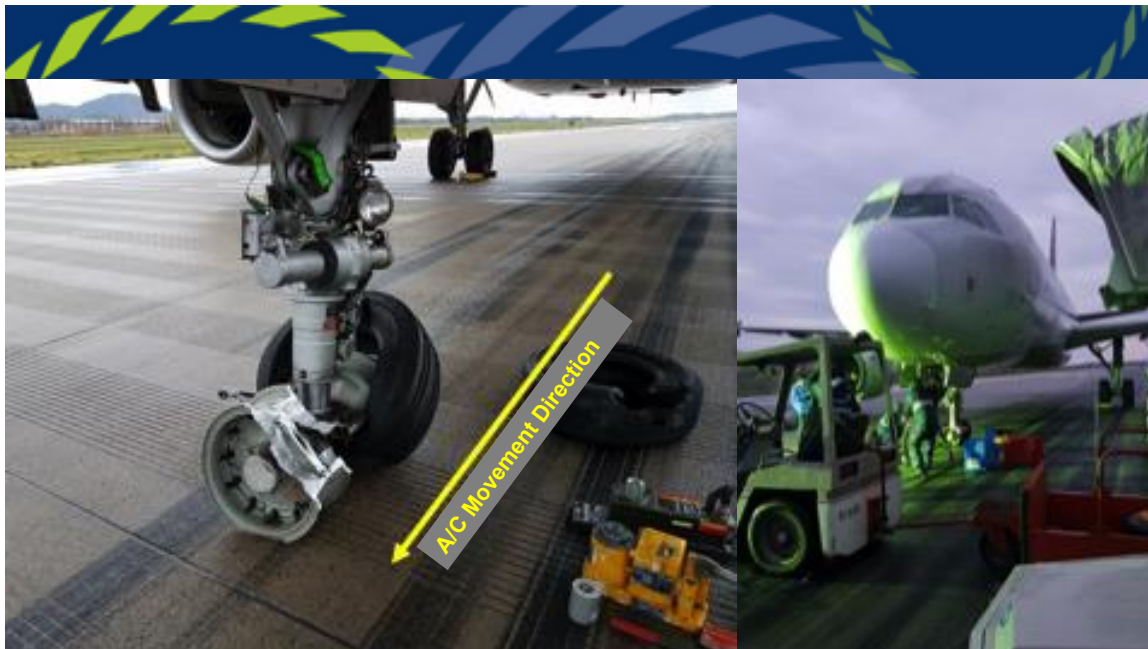
When the ground staff arrived at the aircraft, they found substantial damage to the nose gear and tire, which prevented towing for approximately 24 hours. The passengers were disembarked via external steps.

The subsequent investigation revealed that the event was caused by damage to the Torque link assembly.

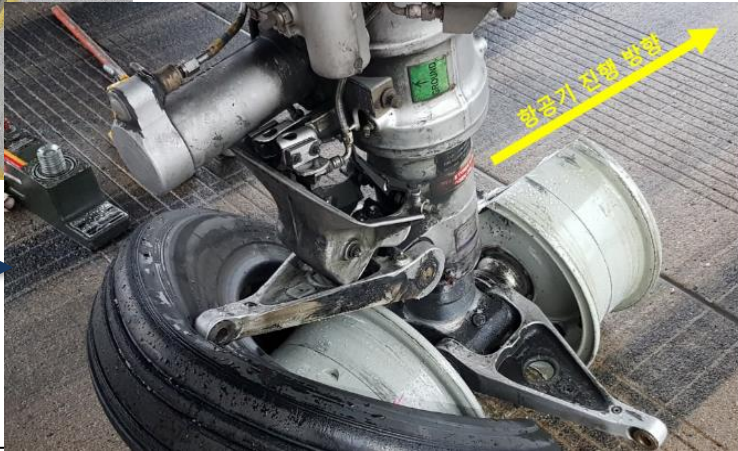
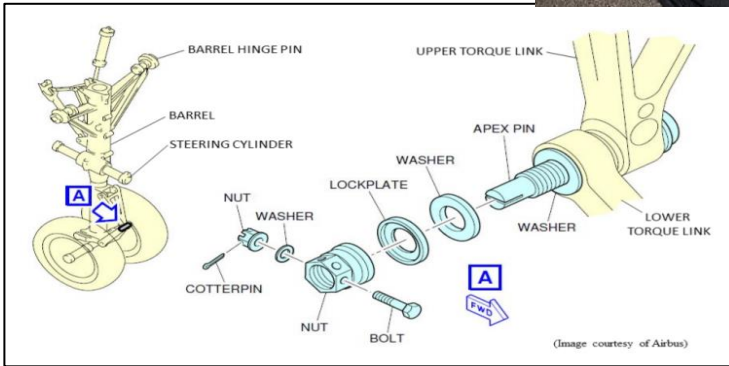
Damaged Torque link Assembly

Reports had previously been made regarding Apex pin-nut detachments, which led to a Service Bulletin (SB) being issued in 2012 that introduced a new type of Apex pin. To prevent the pin-nut from falling from the Apex pin, more screw threads were introduced on the pin and an additional lock plate placed on top of the nut to make it stronger.

The aircraft involved in the incident had the updated Apex pin installed in June 2017. However, it still detached from the torque link assembly. The Apex pin was not broken but it was discovered that the screw threads were partly corroded, which had not been detected during inspections. It can be noted that there were no inspection criteria established for the screw threads. The only requirement was to perform visual checks of the Apex pin at regular intervals.

The failure to detect and remove the worn-out pin was the main contributing factor in this event.

- Important to have all personnel prepared and trained for events of this nature
- The Captain used correct procedures to bring the aircraft to a safe stop
- Aircraft parts were replaced within 24 hours, however, if the Torque link assembly had been checked and the worn-out parts replaced the incident could have been prevented

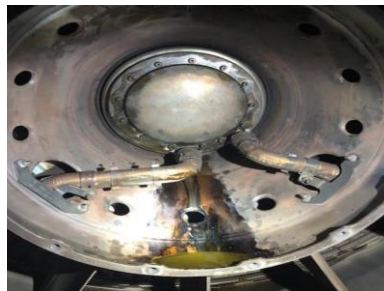
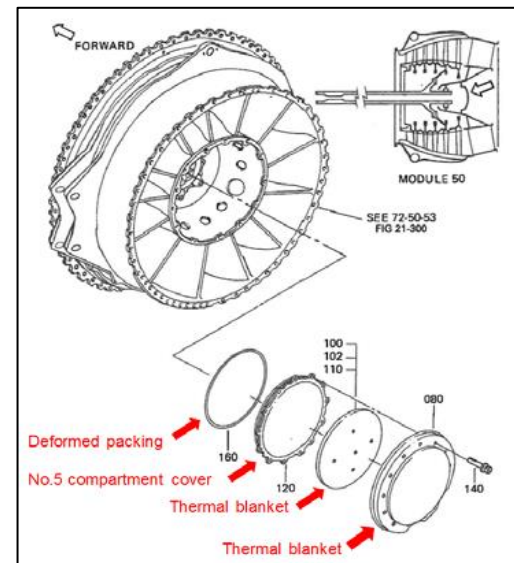
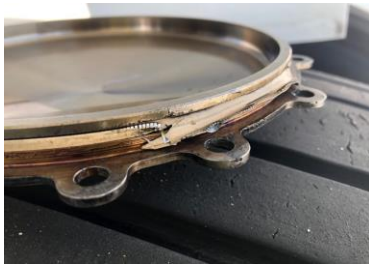
The event flight was the first flight after the completion of a 7,500 hour-check. During the check, the No. 5 bearing compartment cover in ENG1 was replaced. During the installation process, the packing of the compartment cover was damaged and deformed. It was noted that this was the first time the engineer who completed the work had performed this procedure.

During flight, hot oil leaked from the deformed packing and dropped on top of the fire loop, which activated the fire warning when the flight was climbing from FL276 to FL300. The flight crew carried out the ECAM actions, which included shutting down ENG 1.

- The installation of the bearing compartment cover should be supervised – at the time it was considered a routine task
- The maintenance work-card was revised to include a leak check that must be performed prior to re-installing the engine exhaust cone. In this case the leak check was performed, however, with the exhaust cone installed, which visually hid the No. 5 bearing compartment cover
- Establishing an engine pairing policy is an important consideration
- Flightcrew training to include ENG fire and shutdown scenarios during cruise, not only at take-off, should be considered

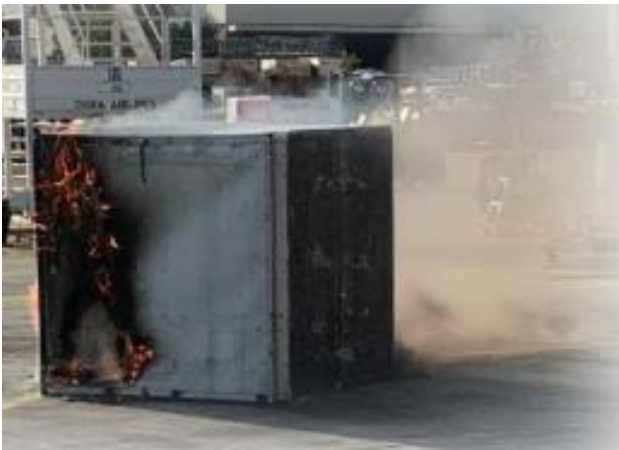
After 11 minutes the container and contents were fully engulfed in flames.
