ISSUE REVIEW MEETING

*2019 ~ IRM 27
Summary Bulletin*

This year's 27th biannual IATA Issue Review Meeting (IRM), the IATA Safety Group (SG) and the IATA Hazard Identification Task Group (HITG) meetings, hosted by Cargolux, were held in Luxembourg, from September 10th to 11th, 2019.

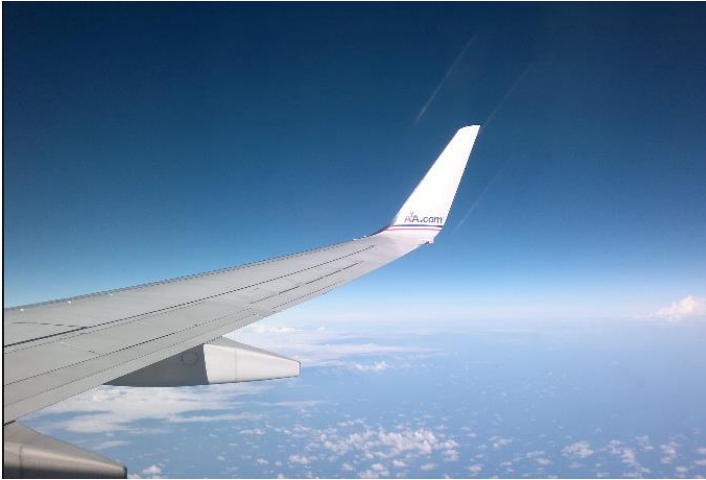
B737 Winglets

The winglets on a B737 are over eight feet tall and approximately four feet wide at the base, narrowing to approximately two feet at the tip, which adds **almost five feet to the total wingspan**. In addition, the top of the winglets extends outward approximately 2.5 feet relative to the winglet's attachment point. This outwards slant is difficult to detect from the flight deck.

- Situational awareness of the perceptual illusions associated with winglets needs to be improved
- Training needs to be improved
- Efforts with Clean Ramp Policy needs to be continued
- An aircraft damage checklist and procedures following a ground collision need to be considered

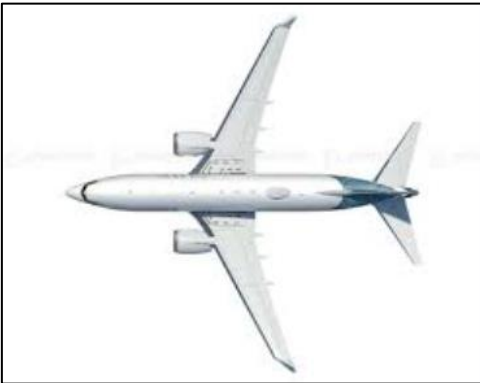
The outer trailing edge of the horizontal stabilizer sweeps back in a v-profile approximately six feet past the tail cone, which means that the trailing edge of the horizontal stabilizer extends six feet past the end of the tail or exhaust port of the APU. Unaware of this configuration and the difficulty of detecting the narrow profile exhibited by the stabilizer, since it exhibits a narrow profile making it appear further away than it actually is, a pilot may inadvertently use the tail cone of the airplane as a reference point to judge the distance between his airplane's wingtip and the other airplane.

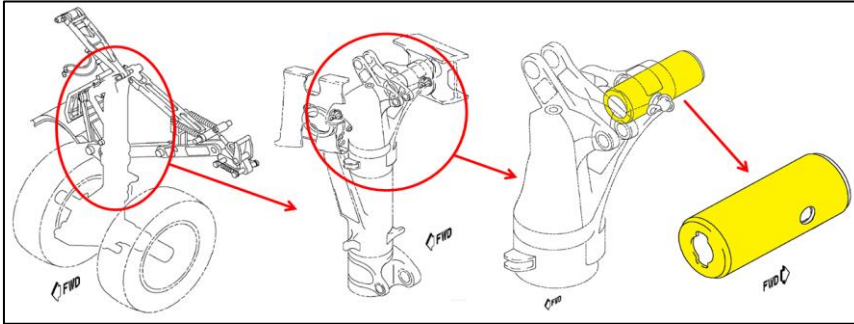
A Boeing 737-800 suffered substantial structural damage when the trunnion pin in the landing gear failed during the landing roll.

The touchdown in good weather conditions was firm, but not hard, with a maximum recorded g-load of 1.48g. After landing, when vacating the runway, the flight crew were informed by the cabin crew about an unusual loud noise coming from the landing gear area.

Engineering subsequently discovered that the aft part of the trunnion pin was missing and that the failure of the trunnion pin had caused substantial damage on other aircraft parts.

- MROs have different automation levels in the machining process parameters, such as: cutting speed, feed rate and depth of cut. Less automation can increase the chance of human errors
- Visual and MPI inspections after the electrodeposition process may detect chromium cracking but not damages to the base metal
- It may not be possible to monitor a pin failure trend since there are no parameter changes during line operations

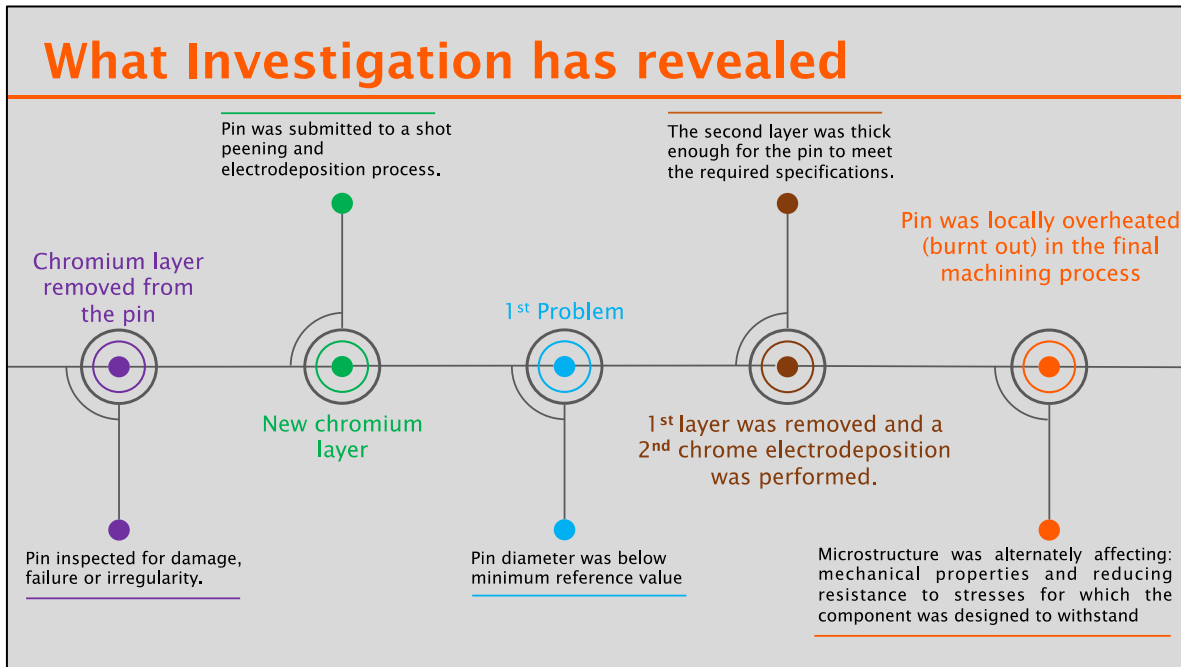
It was concluded that normal operational cycles led to the initiation of a crack in the damaged base metal surface. It also revealed that the trunnion pin installed in the aircraft had been damaged during overhaul when the chromium layer machining process performed by the Maintenance Repair and Operations (MRO) was in disagreement with the procedures established by the manufacturer. Due to fatigue, the crack slowly and steadily propagated up to 20% of the pin wall thickness and unsteadily up to 40% within 3,969 cycles. It was later discovered that another operator with the same aircraft type had suffered similar trunnion pin failures.

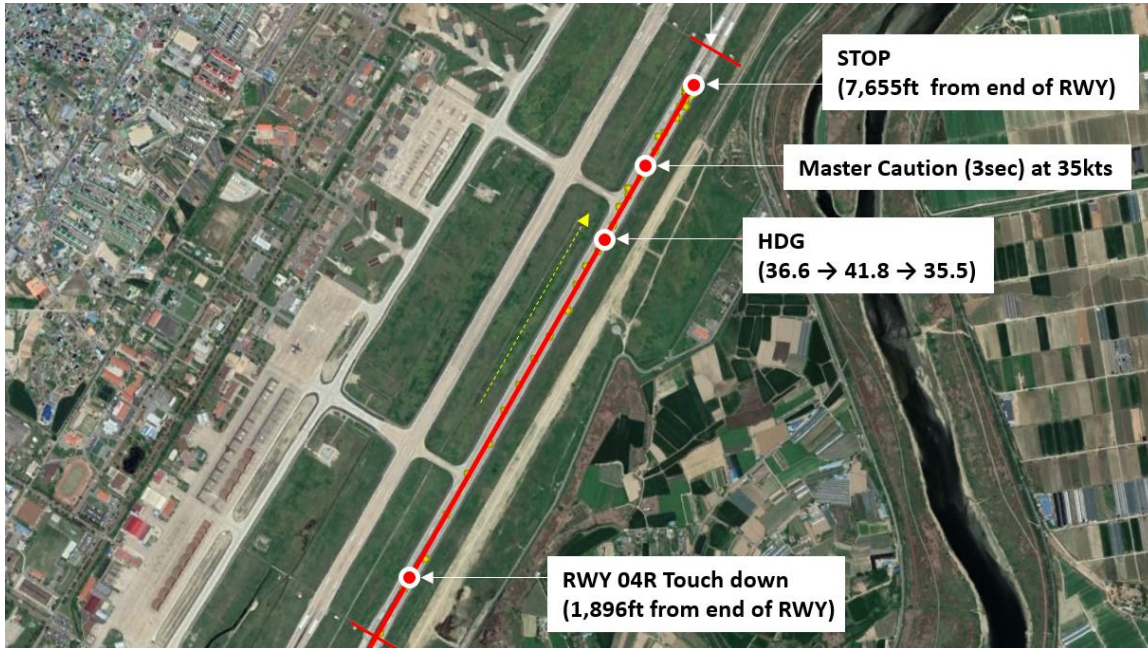
After a normal landing in good weather conditions, an Airbus A320 experienced nose wheel shimmy and severe vibrations during the landing rollout at approximately 80 knots. The Captain stopped the aircraft on the runway due to directional control difficulties and requested towing assistance.

When the ground staff arrived at the aircraft, they found substantial damage to the nose gear and tire, which prevented towing for approximately 24 hours. The passengers were disembarked via external steps.

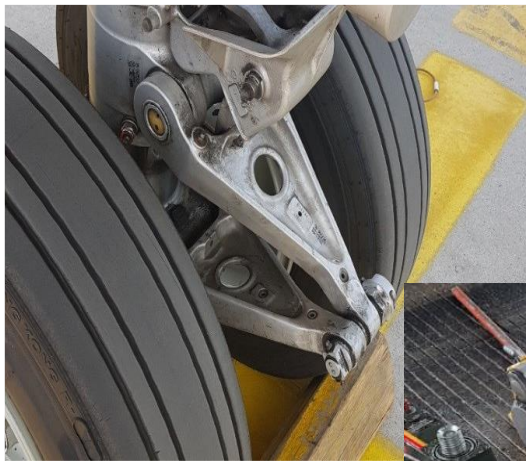
Normal Torque link Assembly

The subsequent investigation revealed that the event was caused by damage to the Torque link assembly.

Damaged Torque link Assembly

- Important to have all personnel prepared and trained for events of this nature
- The Captain used correct procedures to bring the aircraft to a safe stop
- Aircraft parts were replaced within 24 hours, however, if the Torque link assembly had been checked and the worn-out parts replaced the incident could have been prevented

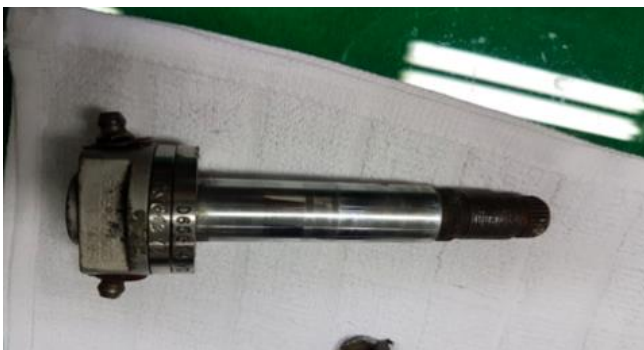
Reports had previously been made regarding Apex pin-nut detachments, which led to a Service Bulletin (SB) being issued in 2012 that introduced a new type of Apex pin. To prevent the pin-nut from falling from the Apex pin, more screw threads were introduced on the pin and an additional lock plate placed on top of the nut to make it stronger.

The aircraft involved in the incident had the updated Apex pin installed in June 2017. However, it still detached from the torque link assembly. The Apex pin was not broken but it was discovered that the screw threads were partly corroded, which had not been detected during inspections. It can be noted that there were no inspection criteria established for the screw threads. The only requirement was to perform visual checks of the Apex pin at regular intervals.

The failure to detect and remove the worn-out pin was the main contributing factor in this event.

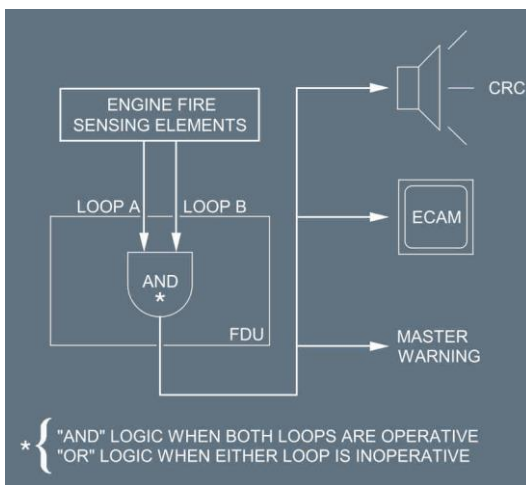
Approximately 50 minutes after take-off from Hong Kong International Airport (VHHH) an ECAM engine fire warning activated for Engine number one (ENG1). The flightcrew shut down the engine according to Airbus Abnormal and Emergency Procedures and the flight diverted to an Enroute Alternate Airport.

The Airbus A321 overheat detection system consists of two identical detection loops (A and B) mounted in parallel and a Fire Detection Unit (FDU). When a sensing element in the loops is subjected to heat it sends a signal to the FDU, and as soon loops A and B detect temperatures above a pre-set level a fire warning is activated.

The event flight was the first flight after the completion of a 7,500 hour-check. During the check, the No. 5 bearing compartment cover in ENG1 was replaced. During the installation process, the packing of the compartment cover was damaged and deformed. It was noted that this was the first time the engineer who completed the work had performed this procedure.

During flight, hot oil leaked from the deformed packing and dropped on top of the fire loop, which activated the fire warning when the flight was climbing from FL276 to FL300. The flight crew carried out the ECAM actions, which included shutting down ENG 1.

- The installation of the bearing compartment cover should be supervised – at the time it was considered a routine task
- The maintenance work-card was revised to include a leak check that must be performed prior to re-installing the engine exhaust cone. In this case the leak check was performed, however, with the exhaust cone installed, which visually hid the No. 5 bearing compartment cover
- Establishing an engine pairing policy is an important consideration
- Flightcrew training to include ENG fire and shutdown scenarios during cruise, not only at take-off, should be considered

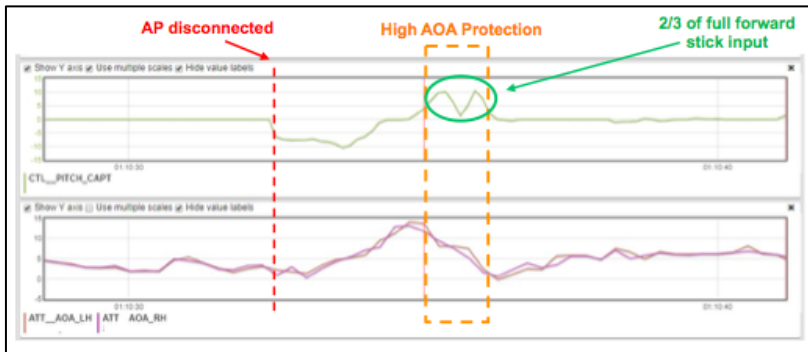
An updraft occurred when the flight was levelling off at FL120, which resulted in an overshoot of the cleared FL by 210 feet. The Autopilot (AP) aggressively corrected the deviation within 19 second, which resulted in a recorded rate of descent of 3,300 feet per minute. To avoid a second altitude deviation, the PF disengaged the AP by applying a 2/3 nose up stick input.

The stick input increased the aircraft pitch from five degrees nose down to zero degrees, which led to a vertical acceleration increase from +0.6g to +2.0g and the activation of the AOA protection. Almost immediately after the activation of AOA protection, the PF applied a 2/3 forward stick input, which deactivated the AOA protection.

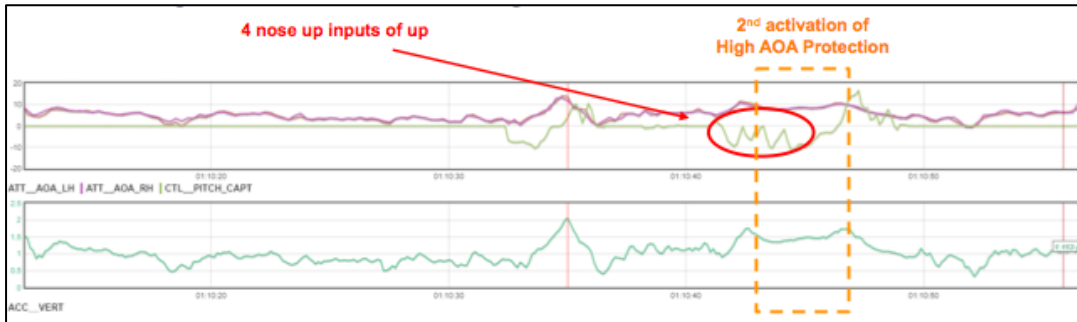
The sum of both back and forward stick inputs partially cancelled each other out and the aircraft continued to descend 724 feet below the cleared FL. To recover from the descent, the PF applied nose up stick inputs, which led to a significant vertical acceleration increase and a second activation of the AOA protection. The PF deactivated the AOA protection by applying a nose down stick input. Shortly thereafter, the crew re-engaged the AP.

During the turbulence encounter, up to 40 degrees left and right roll oscillations were also experienced with and without the autopilot engaged.

The flightcrew were aware of the Airbus turbulence FCOM procedures, however due to the Startle Effect, the PF's immediate reaction was to disengage the AP and attempt to recover from the altitude deviation manually.

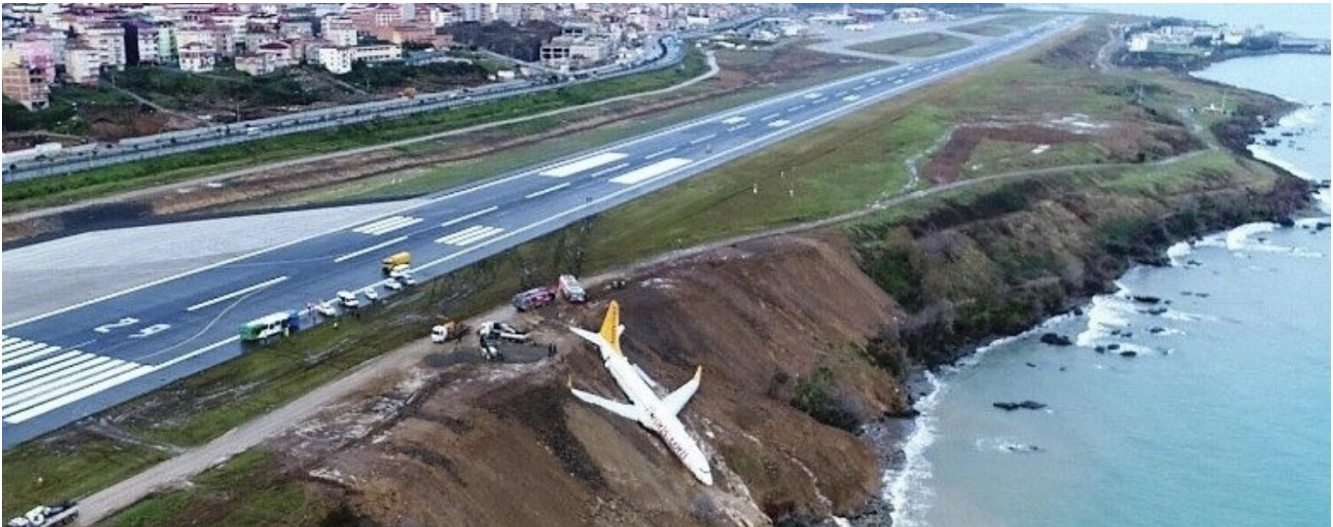
During landing in Trabzon (LTCG) at night in light rain with 4,000 metres visibility, a B737-800 ran off the left side of the wet runway and slid down a cliff towards the Black Sea. The aircraft came to rest in a precarious position along the side of the cliff with the nose of the aircraft facing the sea below. The aircraft was prevented from sliding into the sea due to the ground being wet and the landing gear being stuck in the muddy ground. All passengers and crew evacuated safely with no injured, but the aircraft sustained substantial damage.

- A significant thrust asymmetry occurred when both TO/GA switches were pushed instead of the Autothrottle (A/T) disengage buttons, which led to the right engine developing TOGA thrust with the left engine in reverse during the landing rollout
- A contributing factor was the use of dual autopilots during approach, which resulted in an automatic nose up trim in anticipation of a go-around. The sudden pitch up moment when the autopilot was disengaged caused some disorientation

- Face-to-face meetings with all related department managers have been held to identify improper management systems which may cause future incidents
- Studies have been initiated to take steps to make the quality of Flight Crew Training even better

- CAT I approaches will be accomplished with single autopilot; dual autopilot will be used only in CAT II/III LVP conditions
- Autopilot (Boeing and Airbus) and autothrottle (Boeing) will be disengaged at minimums for IMC conditions and latest at 1,000 feet agl in VMC conditions if the runway is insight

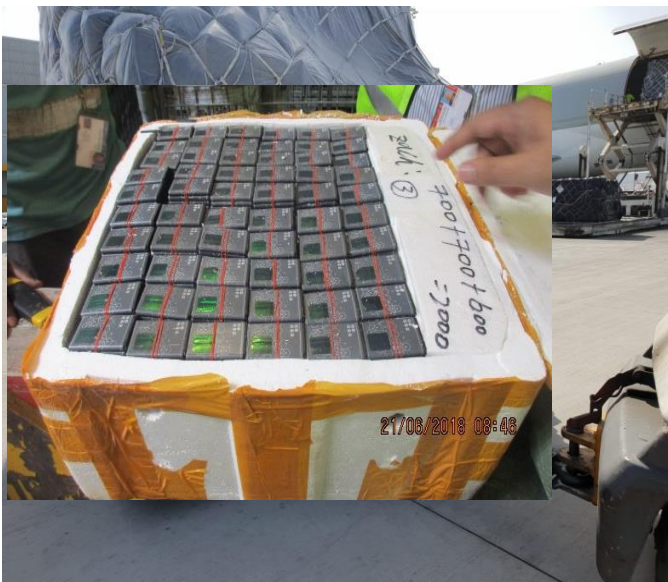
Shortly after being offloaded at the airline’s home base, a pallet containing part of the shipment began to smoke and within a few minutes a box at the bottom of the pallet exploded less than 50 metres away from the aircraft.

The shipment included 103 packages with 1000 – 2000 standalone lithium batteries & power banks

The IATA limit is 2 standalone lithium batteries per package.

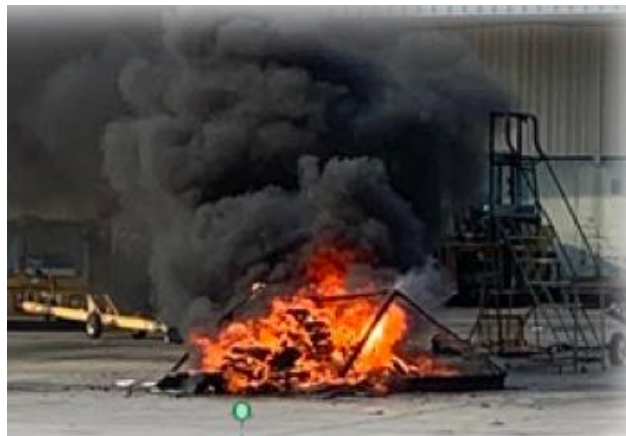
After 11 minutes the container and contents were fully engulfed in flames.

- The shipment contained laptops packed in file boxes available from office supply stores
- All documentation was in order with the packages appropriately labelled
- The commodity was accurately declared but the packing requirements and screening requirements failed to detect the damaged laptops
- Turbulence experienced on the flight where the shipment should have been loaded could have created the same shocks as applied by the GHA Staff
